TECHNICAL REPORT H-77-22

BREAKWATER STABILITY STUDY IMPERIAL BEACH, CALIFORNIA

Hydraulic Model Investigation

Prepared for U. S. Army Engineer District, Los Angeles
Los Angeles, California 90053

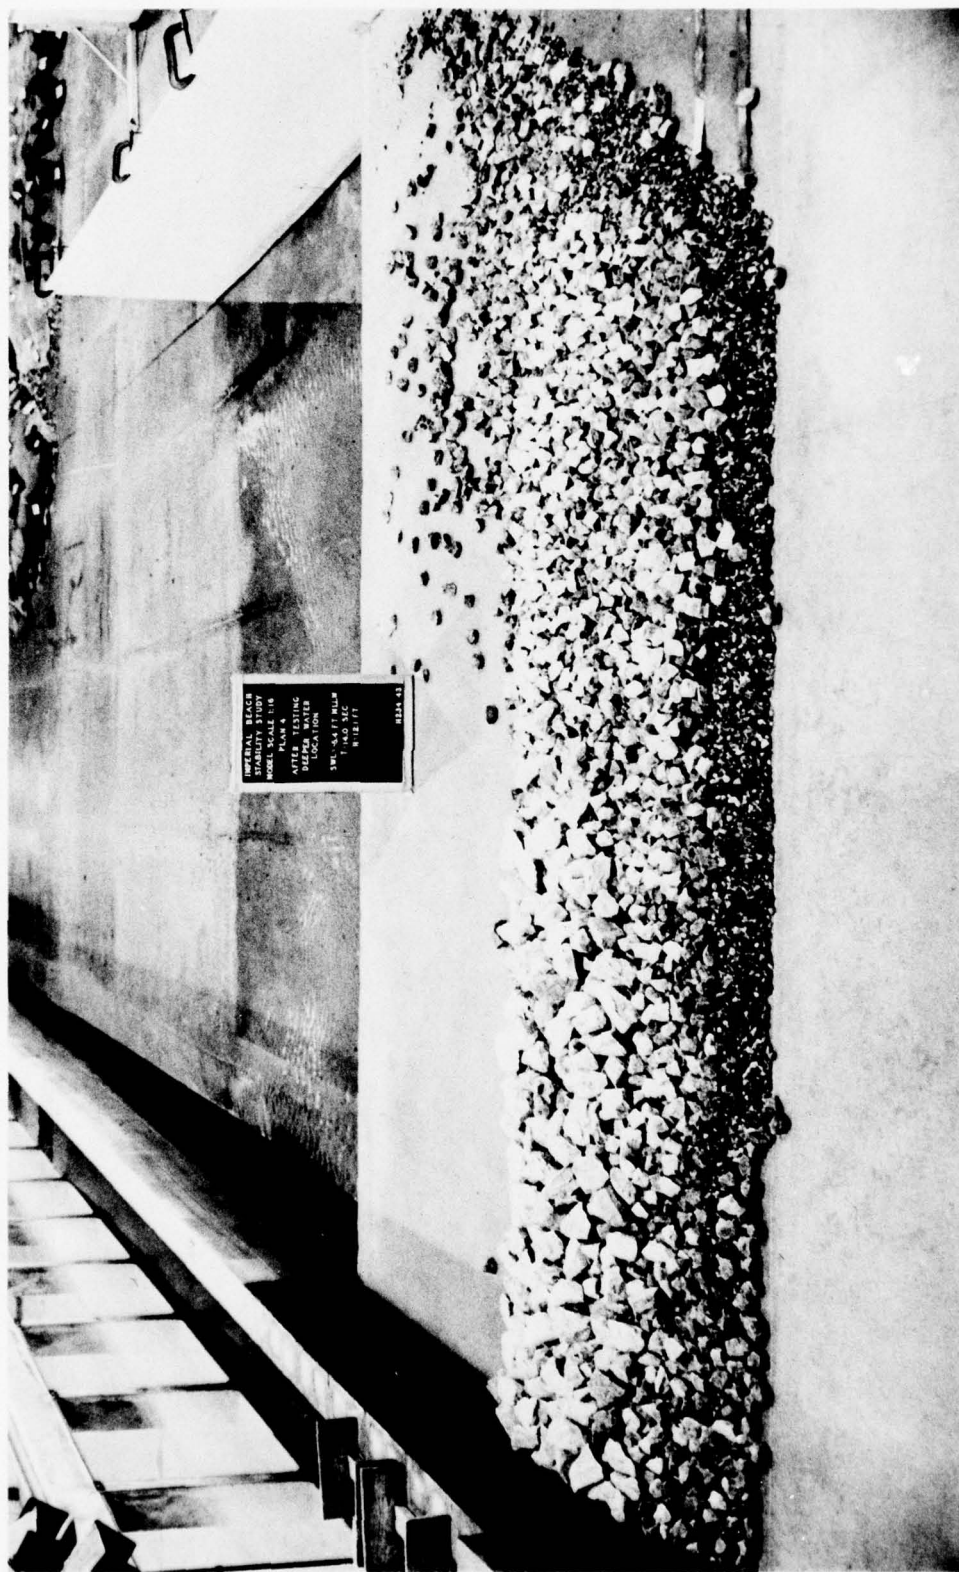
Photo 16. Sea-side view of Plan 4 in the deeper water location after 2.0 hr of 14.0-sec, 12.1-ft waves at an swl of +5.4 ft mllw

15. Plan 4 (Plate 4 and Photo 14) was constructed in the deeper water location to high- and low-sill elevations of +6.0 ft and -3.0 ft mllw, respectively. The high sill was armored with 5.0-ton stone and the low sill used 1750-lb stone. The 5.0-ton and 1750-lb stone were built to slopes of 1V on 2H and 1V on 1.5H, respectively. Attack of 14.0-sec, 8.3-ft waves at an swl of 0.0 ft mllw for 1.5 hr produced only minor damage (Photo 15); however, test conditions were changed to 14.0-sec, 12.1-ft waves at an swl of +5.4 ft mllw and 2.0 hr of wave attack produced extensive damage to both the low- and high-sill sections of the structure (Photo 16).

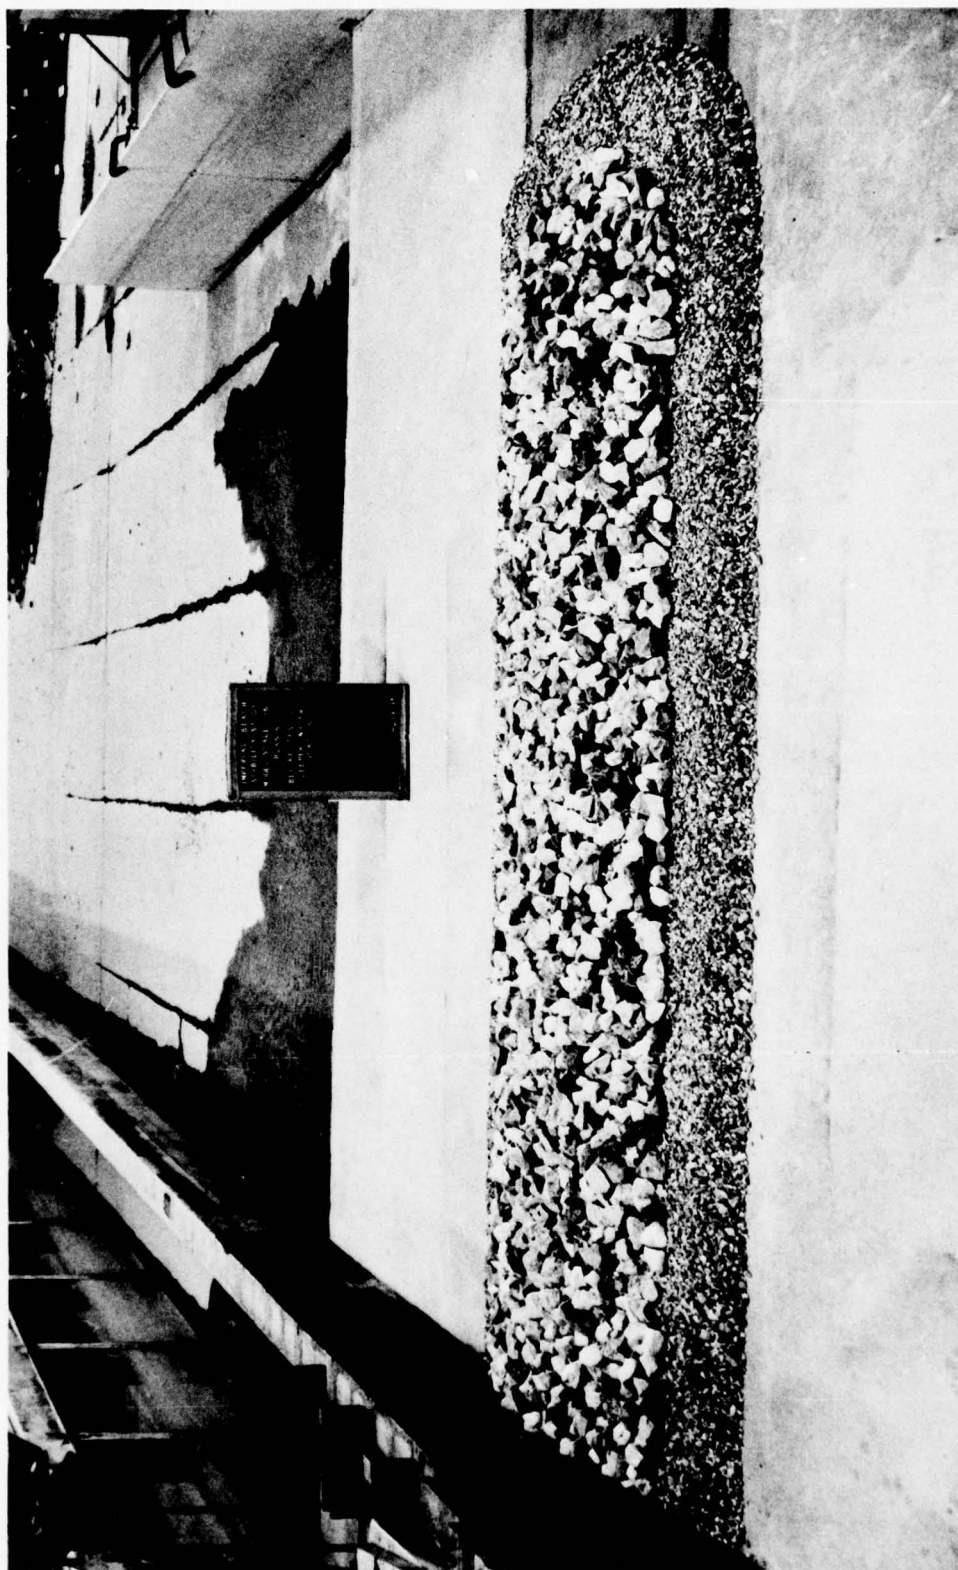
Photo 17. Sea-side view of Plan 5 before wave attack

16. Plan 5 (Plate 5 and Photo 17) was a substantial departure from the alternating low- and high-sill concept employed in Plans 1-4. Plan 5 was constructed to a constant crown elevation of 0.0 ft mllw in the deeper water location and +5.0 ft mllw in the shallow-water location. The armor stone was graded by weight percentage from a maximum of 3.0 tons to a minimum of less than 6.0 lb (3-ton graded armor stone as given in Plate 5 or Table 1). Armor slopes of 1V on 3H were used both sea side and beach side. Testing in the deeper water location with 14.0-sec, 8.3-ft waves at an swl of 0.0 ft mllw produced only minor damage after 1.5 hr of exposure (Photo 18); however, exposure to 14.0-sec, 12.1-ft waves at an swl of +5.4 ft mllw for 2.0 hr resulted in extensive damage (Photo 19). It was deemed advantageous to test Plan 5 in the shallow-water location since it was thought it might prove to be more economical than Plan 3. After rebuilding the breakwater, testing in the shallow-water location with 14.0-sec, 4.5-ft waves at an swl of

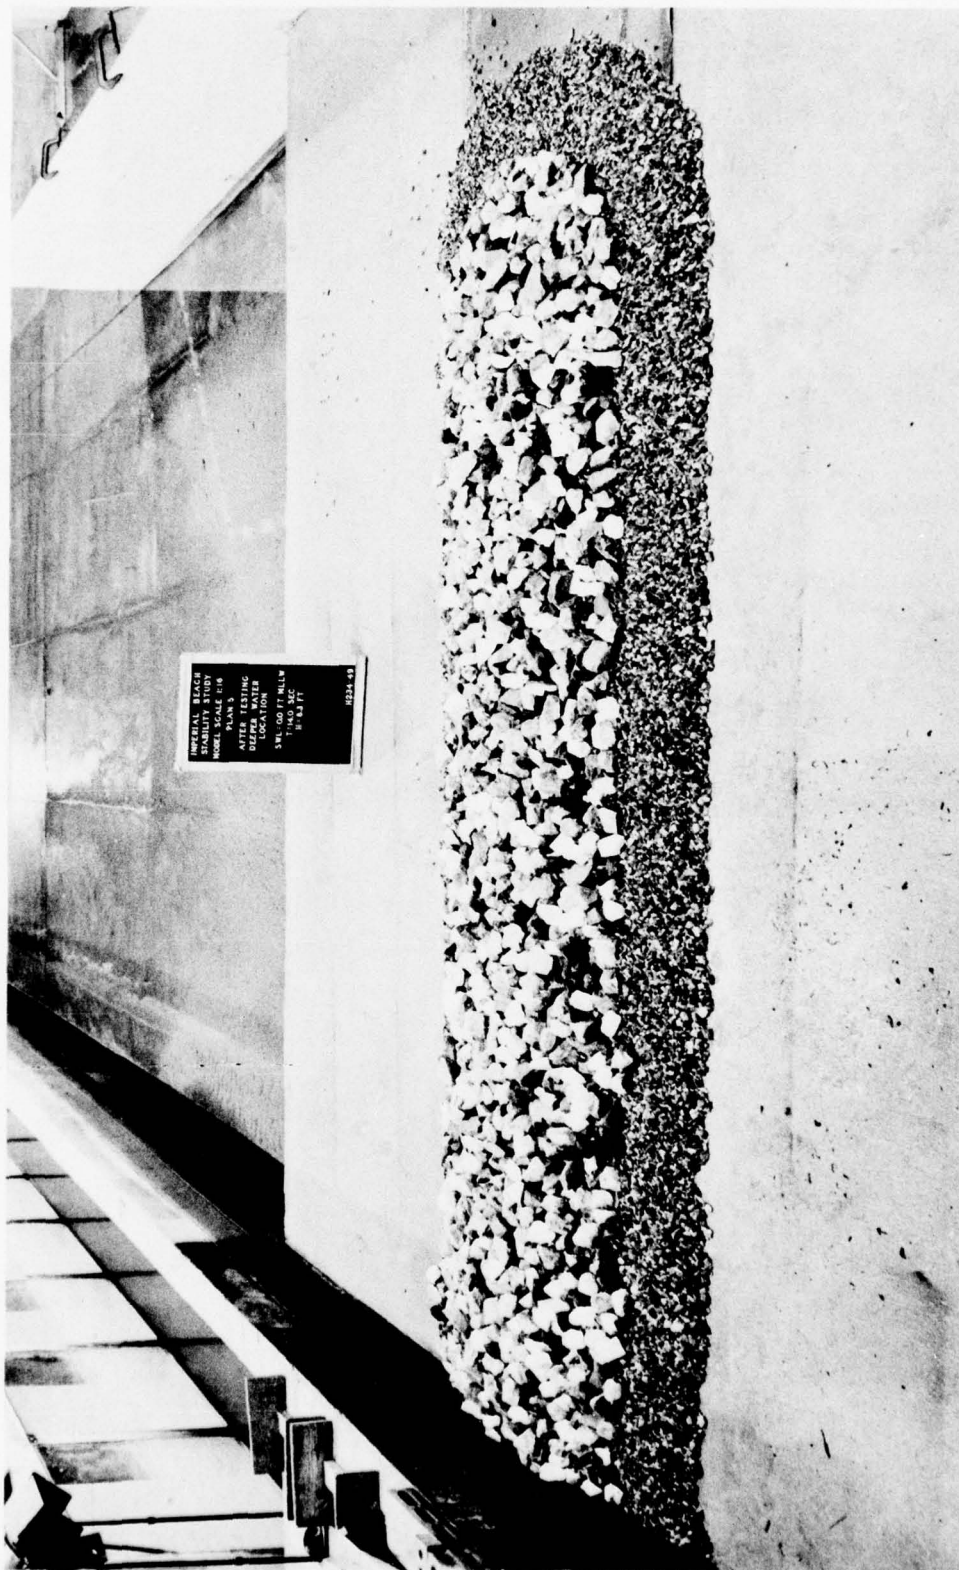
Photo 18. Sea-side view of Plan 5 in the deeper water location after 1.5 hr of 14.0-sec, 8.3-ft waves at an swl of 0.0 ft mllw

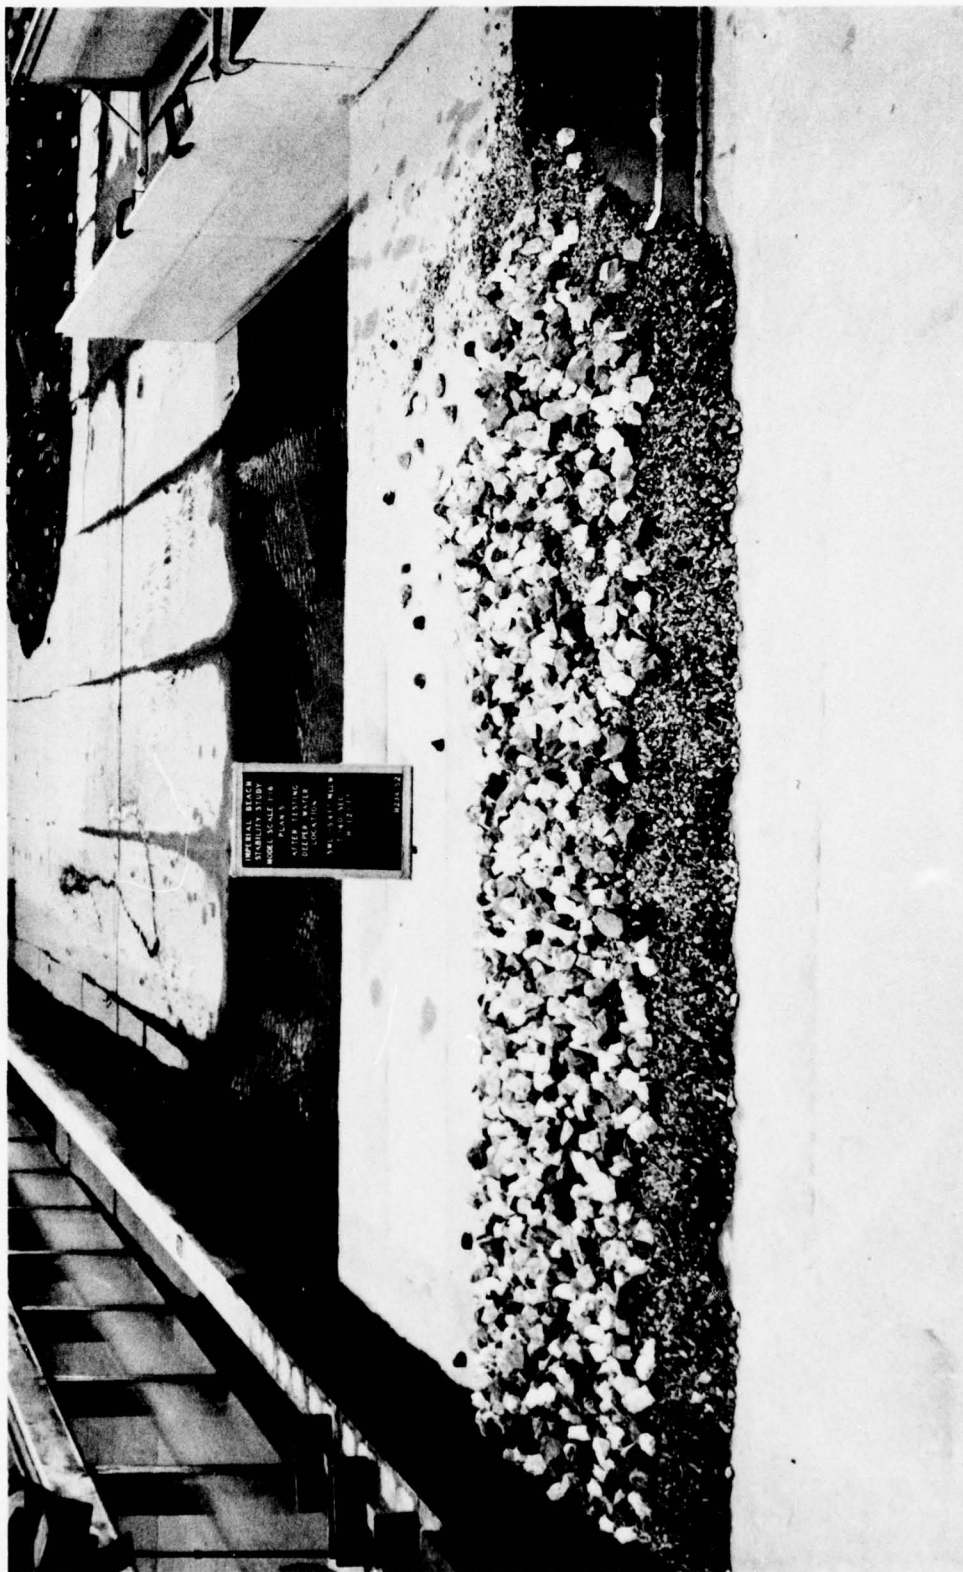
Photo 19. Sea-side view of Plan 5 in the deeper water location after 2.0 hr of 14.0-sec, 12.1-ft waves at an swl of +5.4 ft mllw

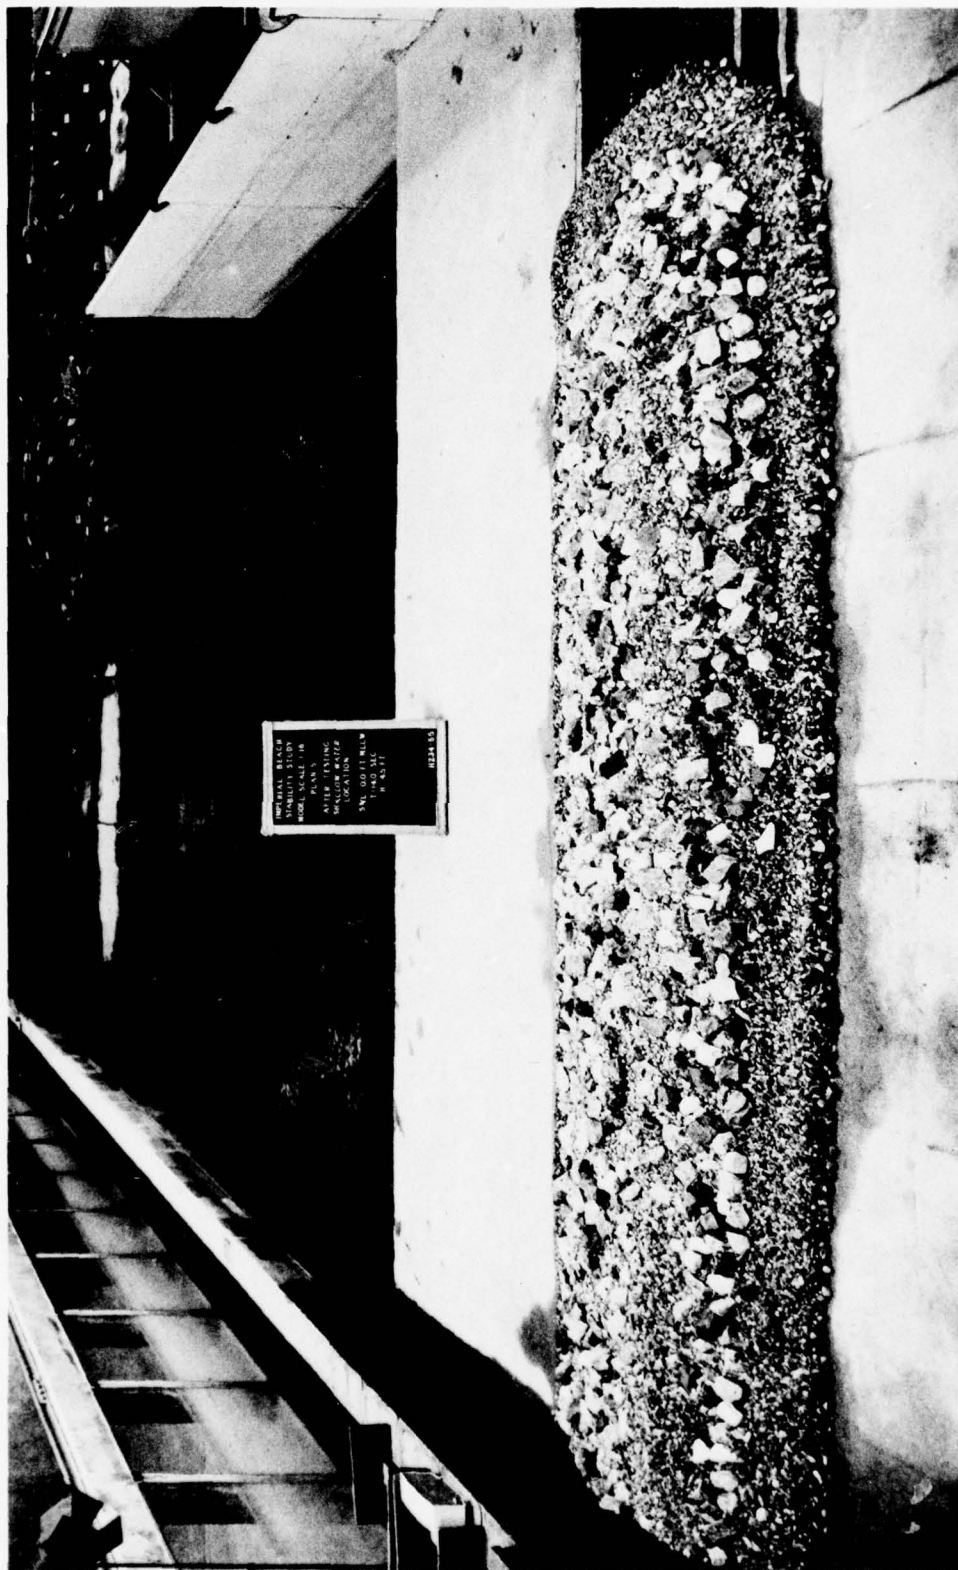
Photo 20. Sea-side view of Plan 5 in the shallow-water location after 1.5 hr of 14.0-sec, 4.5-ft waves at an swl of 0.0 ft mllw

0.0 ft mllw produced significant toe stone movement, but only minor damage to the primary armor mix (Photo 20). Wave attack was continued for 2.0 hr using 14.0-sec, 8.5-ft waves at an swl of +5.4 ft mllw and this resulted in minor to moderate damage to all sections of the breakwater (Photo 21).

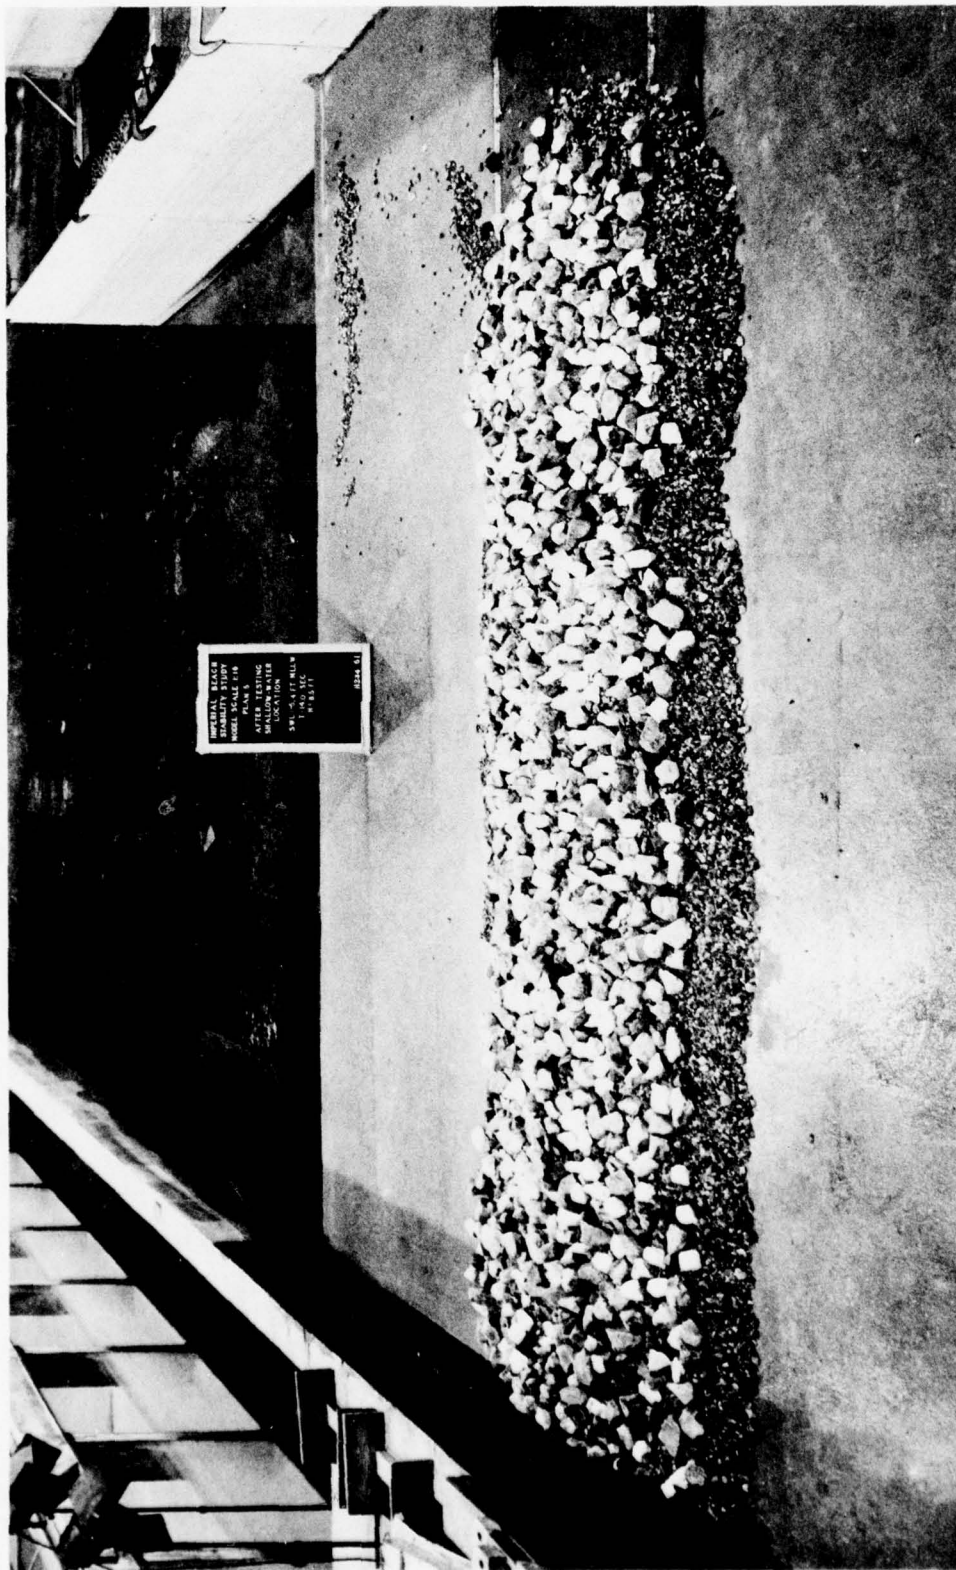
Photo 21. Sea-side view of Plan 5 in the shallow-water location after 2.0 hr of 14.0-sec, 8.5-ft waves at an swl of +5.4 ft mllw

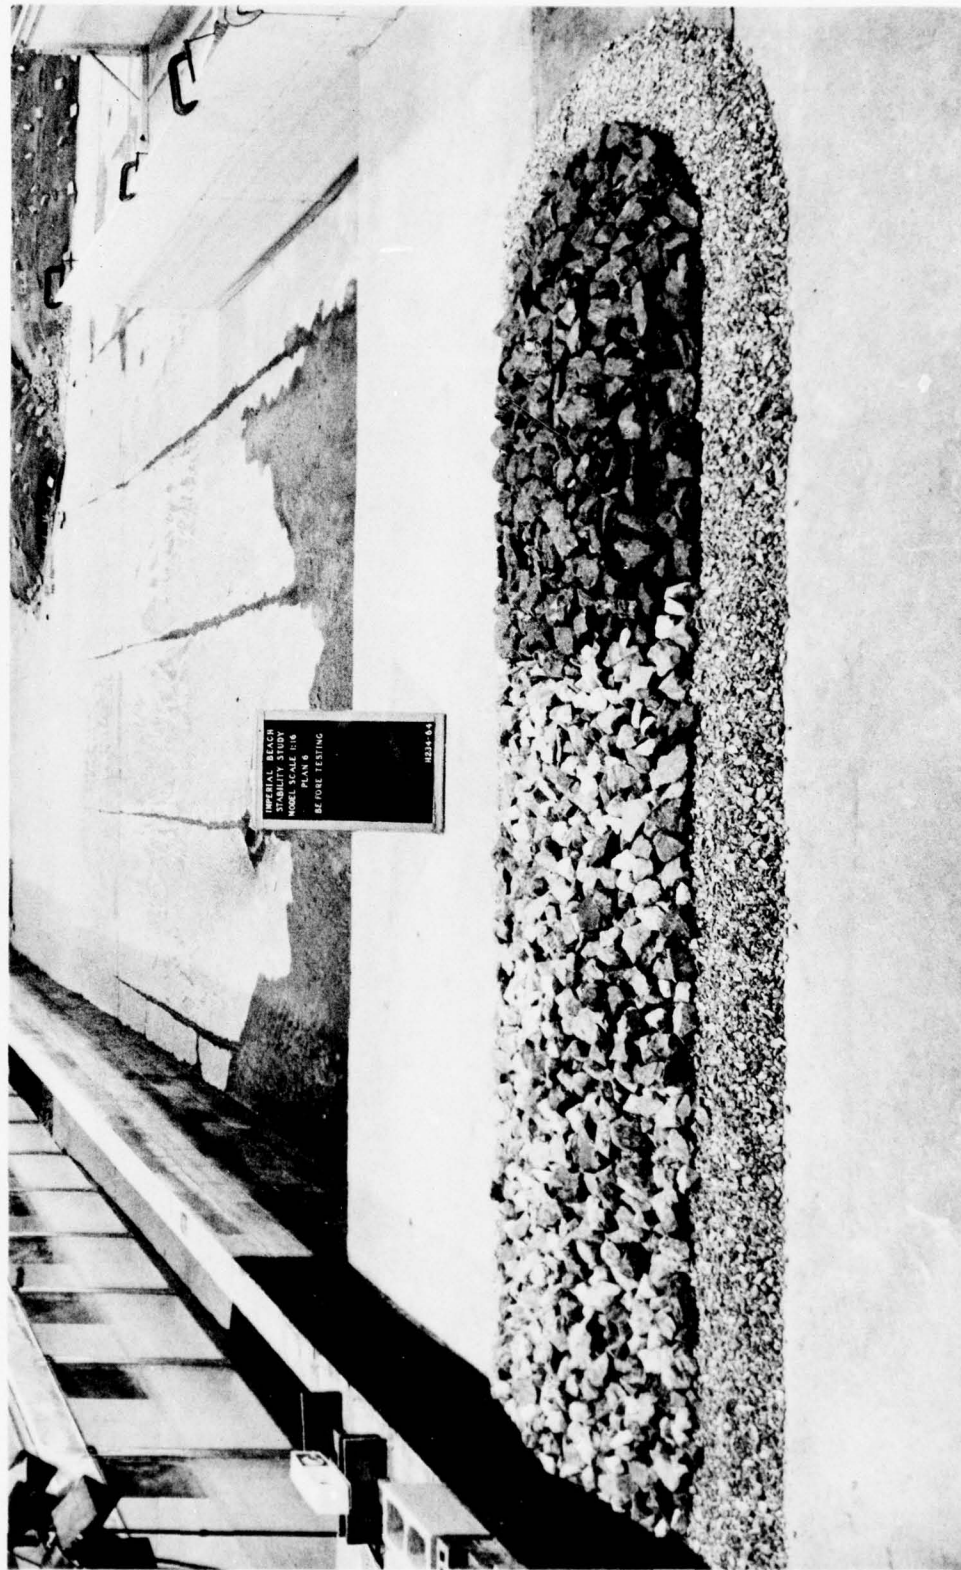
Photo 22. Sea-side view of Plan 6 before wave attack

17. Plan 6 (Plate 6 and Photo 22) was constructed on a 2-ft-thick layer of 25-lb filter stone to a constant crown elevation of +1.0 ft mllw in the deeper water location. The trunk portion of the breakwater was constructed with 1V on 3H slopes using graded armor stone that ranged from a maximum of 5.0 tons to a minimum of less than 6.0 lb (5-ton graded armor stone as given in Plate 6 or Table 1). Maximum and minimum porosity of the 5-ton graded armor stone as determined by model measurement was 44 percent and 40 percent, respectively. The breakwater head and the adjacent 50 ft of trunk incorporated this same graded armor stone in a 4.5-ft-thick core and was capped with one layer of 5.0-ton armor stone placed on 1V-on-3H slopes. Attack by 14.0-sec, 8.3-ft waves at an swl of 0.0 ft mllw for 1.5 hr produced only minor damage (Photo 23). The swl was then raised to +5.4 ft mllw; and after 2.0 hr of attack by 14.0-sec, 12.1-ft waves, the breakwater showed moderate damage (Photo 24). After 4.0 hr more of wave attack (a total of 6.0 hr) by 14-sec, 12.1-ft waves, the damage to the trunk section increased slightly while the damage to the head was significant (Photo 25). An additional 2 hr (a total of 8.0 hr) of exposure to the same wave condition resulted in extensive but stabilized damage to the entire test section (Photo 26).

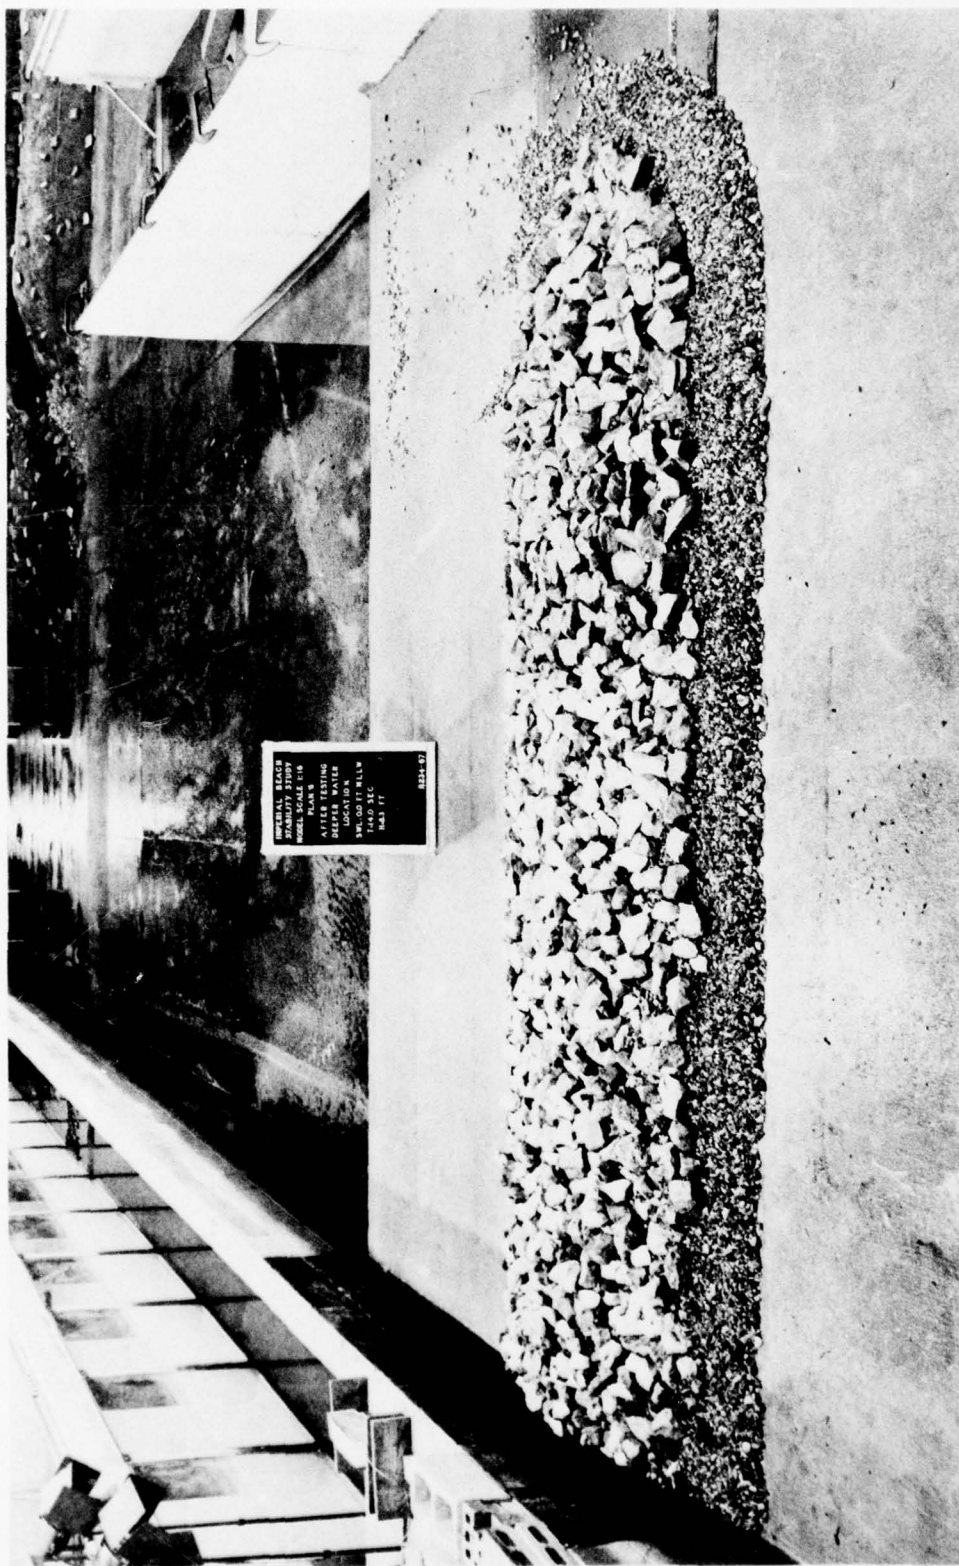
Photo 23. Sea-side view of Plan 6 in the deeper water location after 1.5 hr of 14.0-sec, 8.3-ft waves at an swl of 0.0 ft mllw

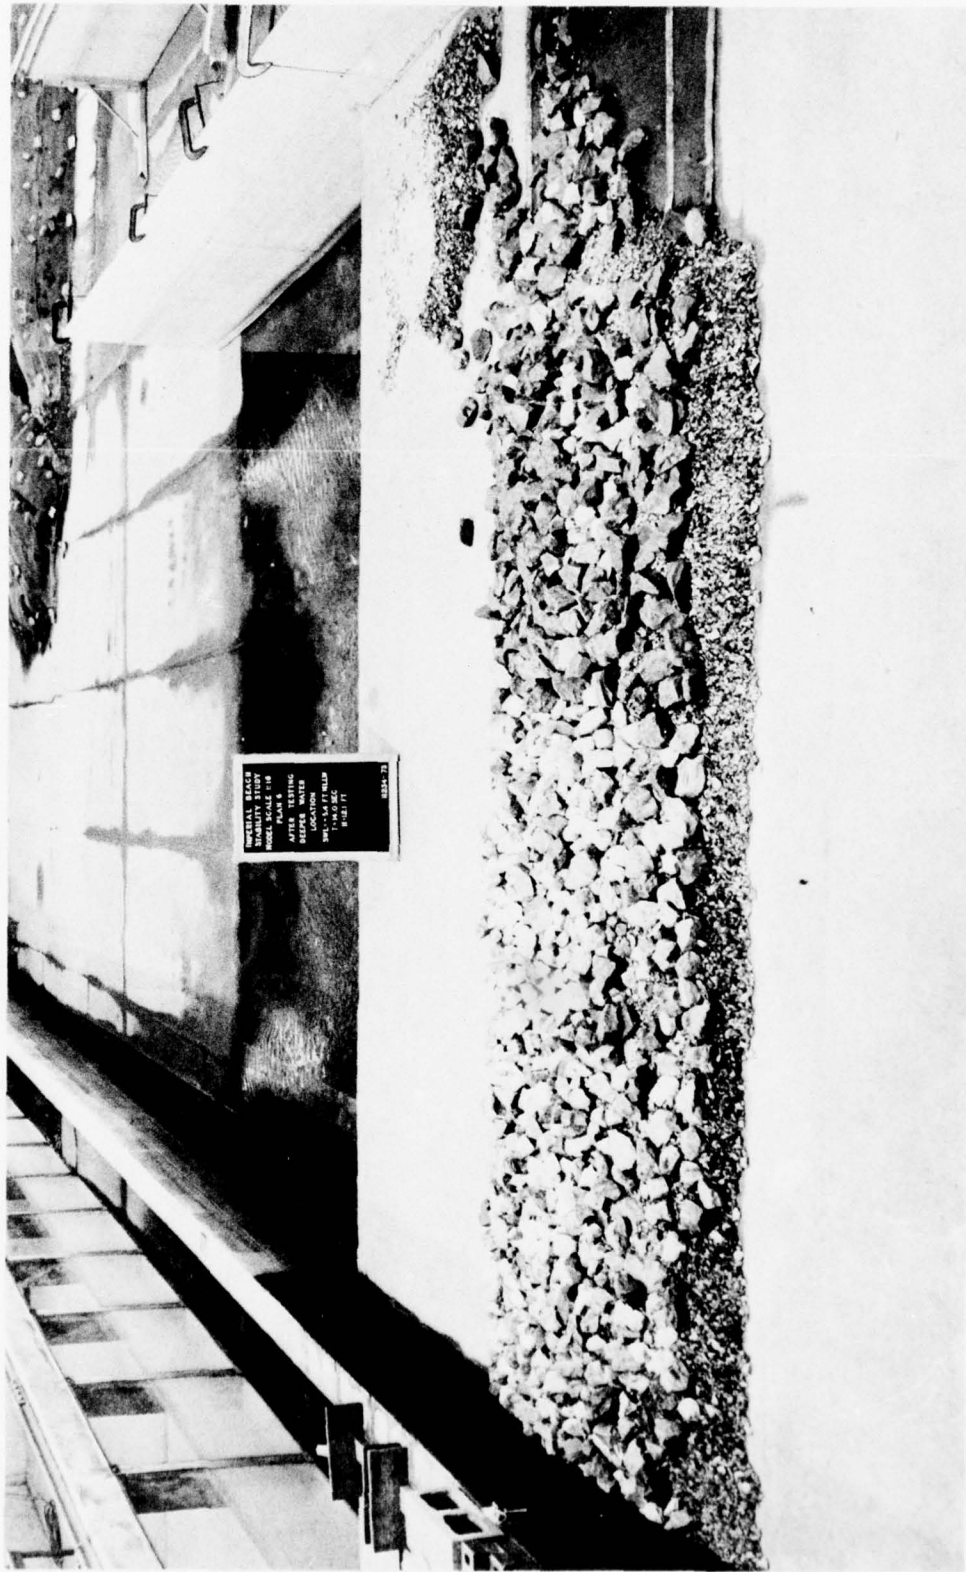
Photo 25. Sea-side view of Plan 6 in the deeper water location after 6.0 hr of 14.0-sec, 12.1-ft waves at an swl of +5.4 ft mllw

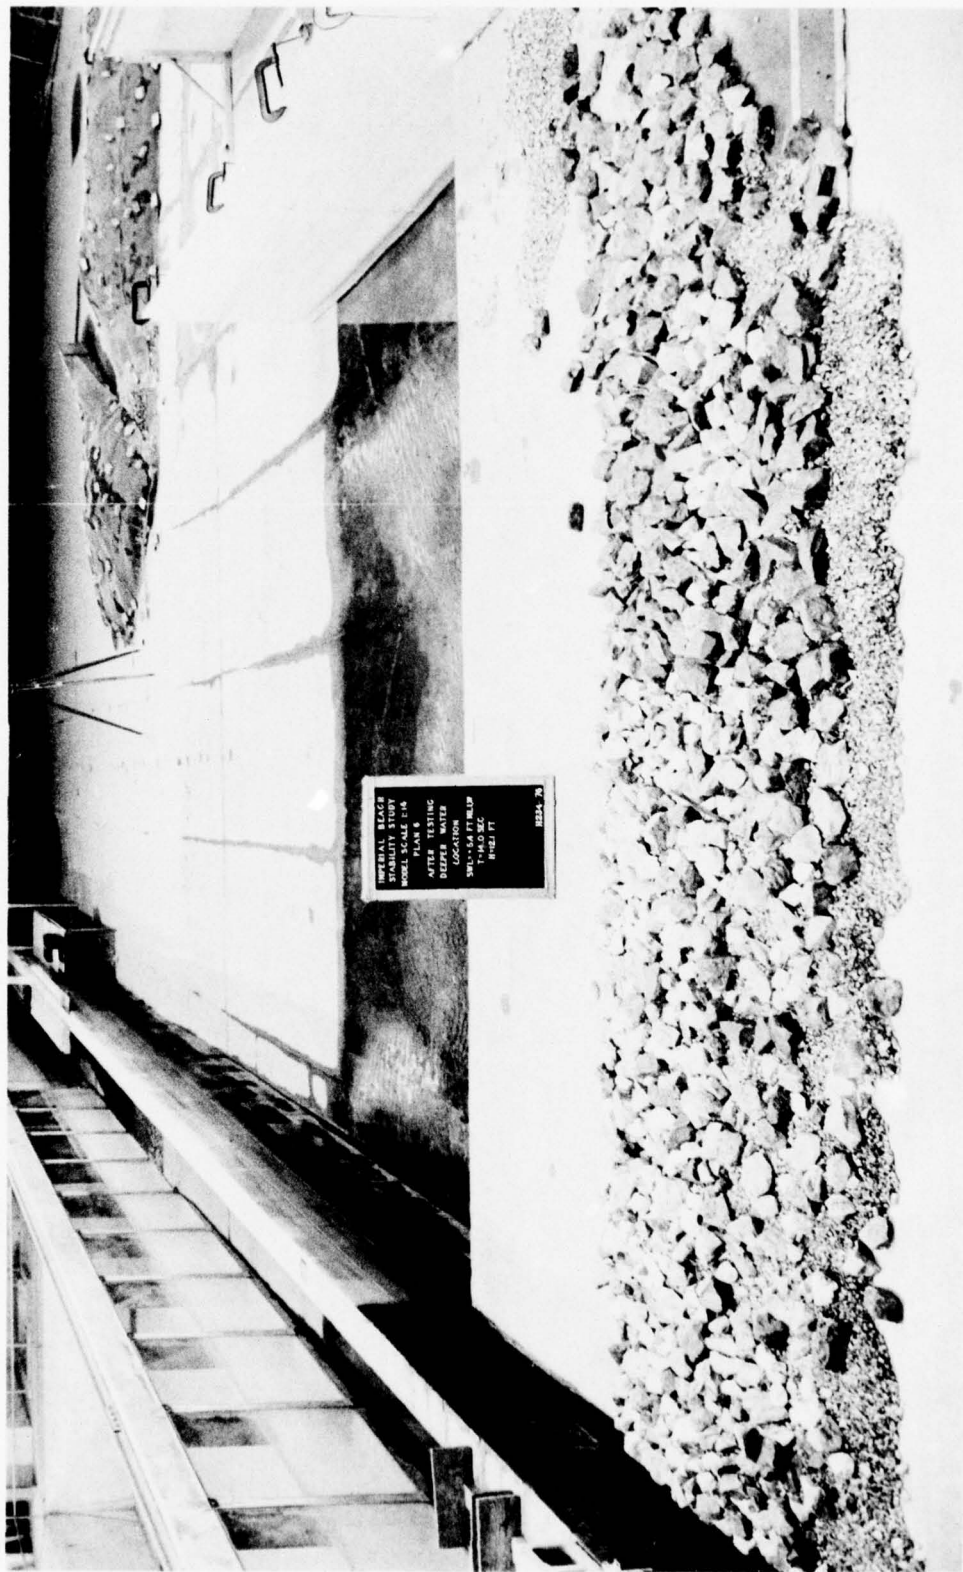
Photo 26. Sea-side view of Plan 6 in the deeper water location after 8.0 hr of 14.0-sec, 12.1-ft waves at an swl of +5.4 ft mllw

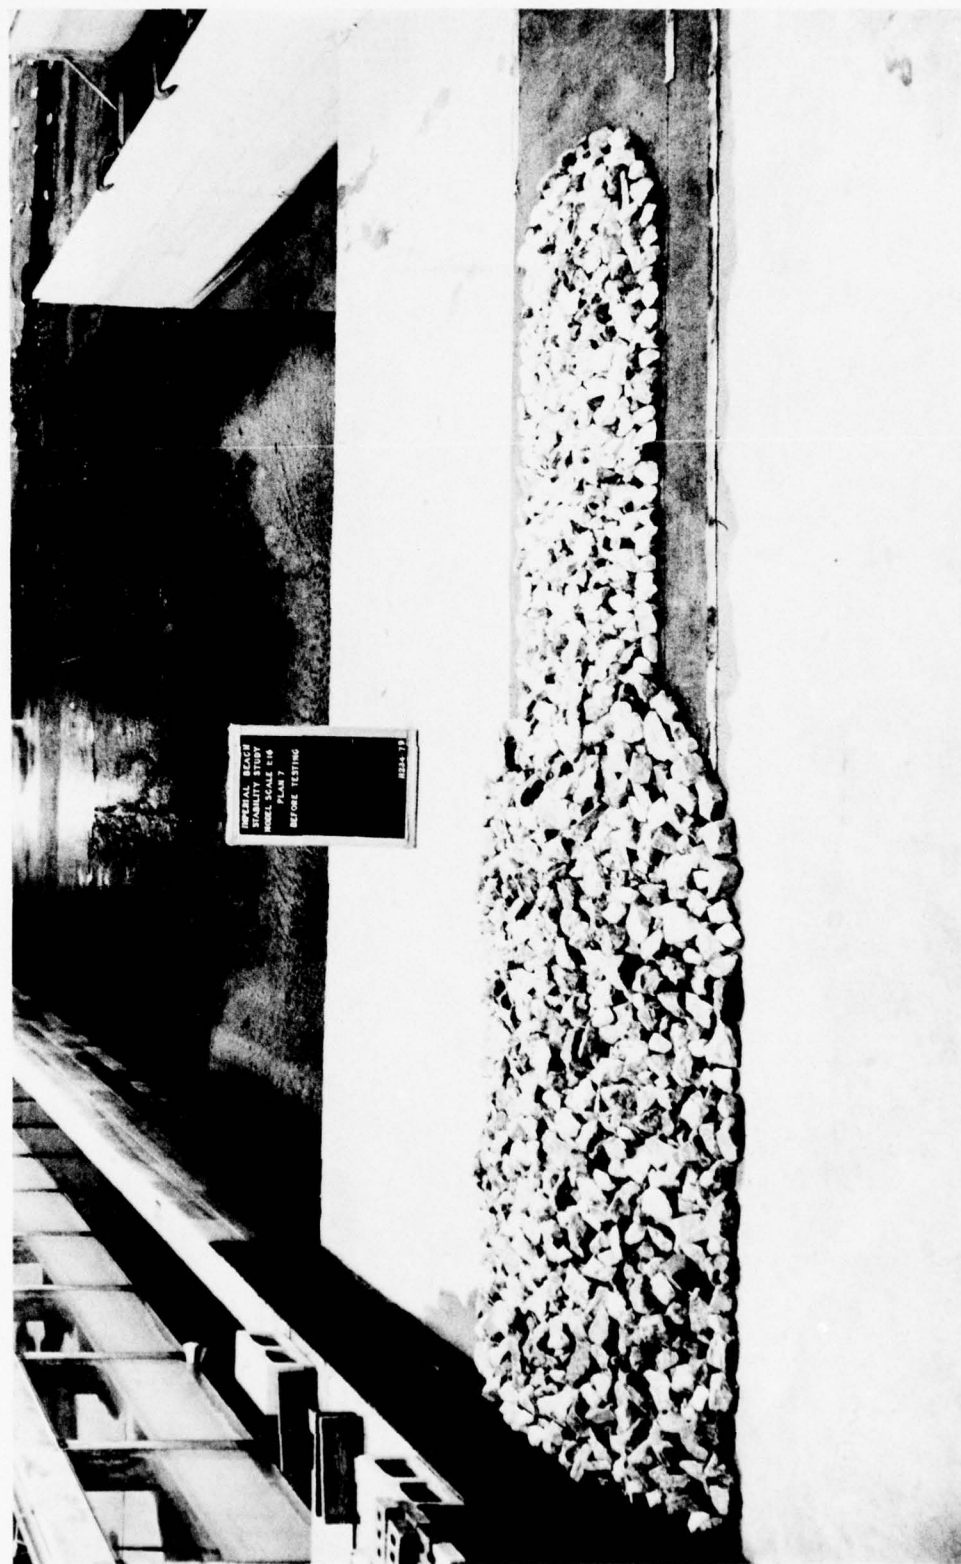
Photo 27. Sea-side view of Plan 7 before wave attack

18. Plan 7 (Plate 7 and Photo 27) returned to the alternating high- and low-sill concept for the deeper water location, but removed the 25-lb stone filter layer with the assumption that the rock filter would be replaced with filter cloth. The high sill was constructed with 1V-on-3H slopes to a crown elevation of 0.0 ft mllw using 5.0-ton graded armor stone. Using 3.0-ton graded armor stone, the low sill was constructed with 1V-on-3H slopes to a crown elevation of -5.0 ft mllw. After experiencing 1.5 hr of attack by 14.0-sec, 8.3-ft waves at an swl of 0.0 ft mllw, the structure had sustained very minor damage (Photo 28) and was considered stabilized for this test condition. The test

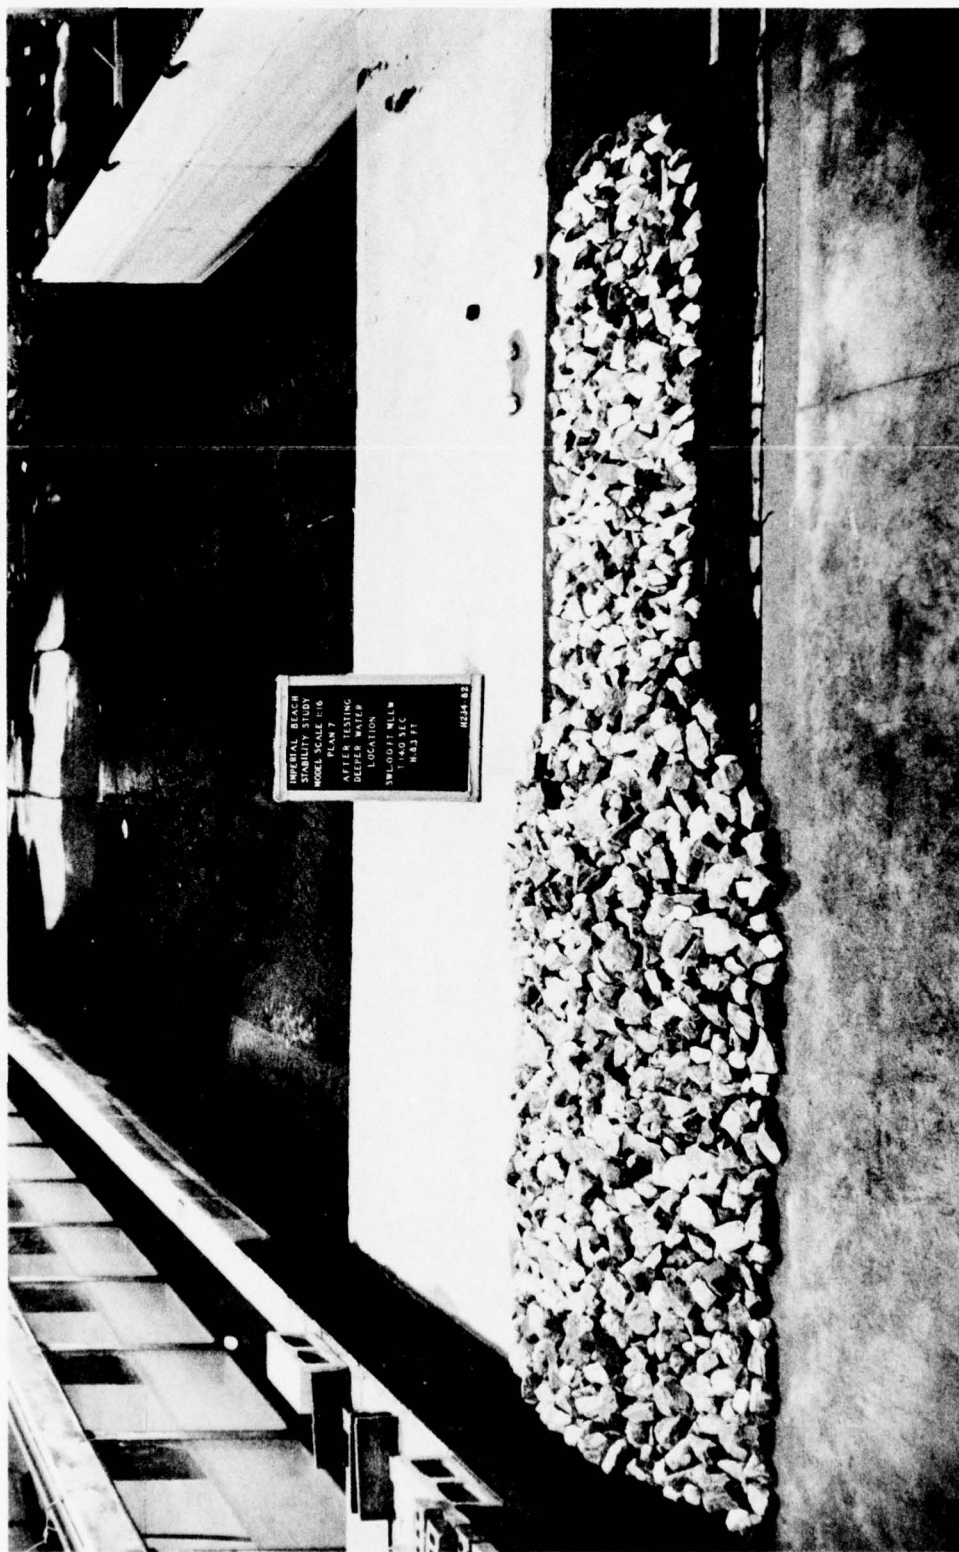
Photo 28. Sea-side view of Plan 7 in the deeper water location after 1.5 hr of 14.0-sec, 8.3-ft waves at an swl of 0.0 ft mllw

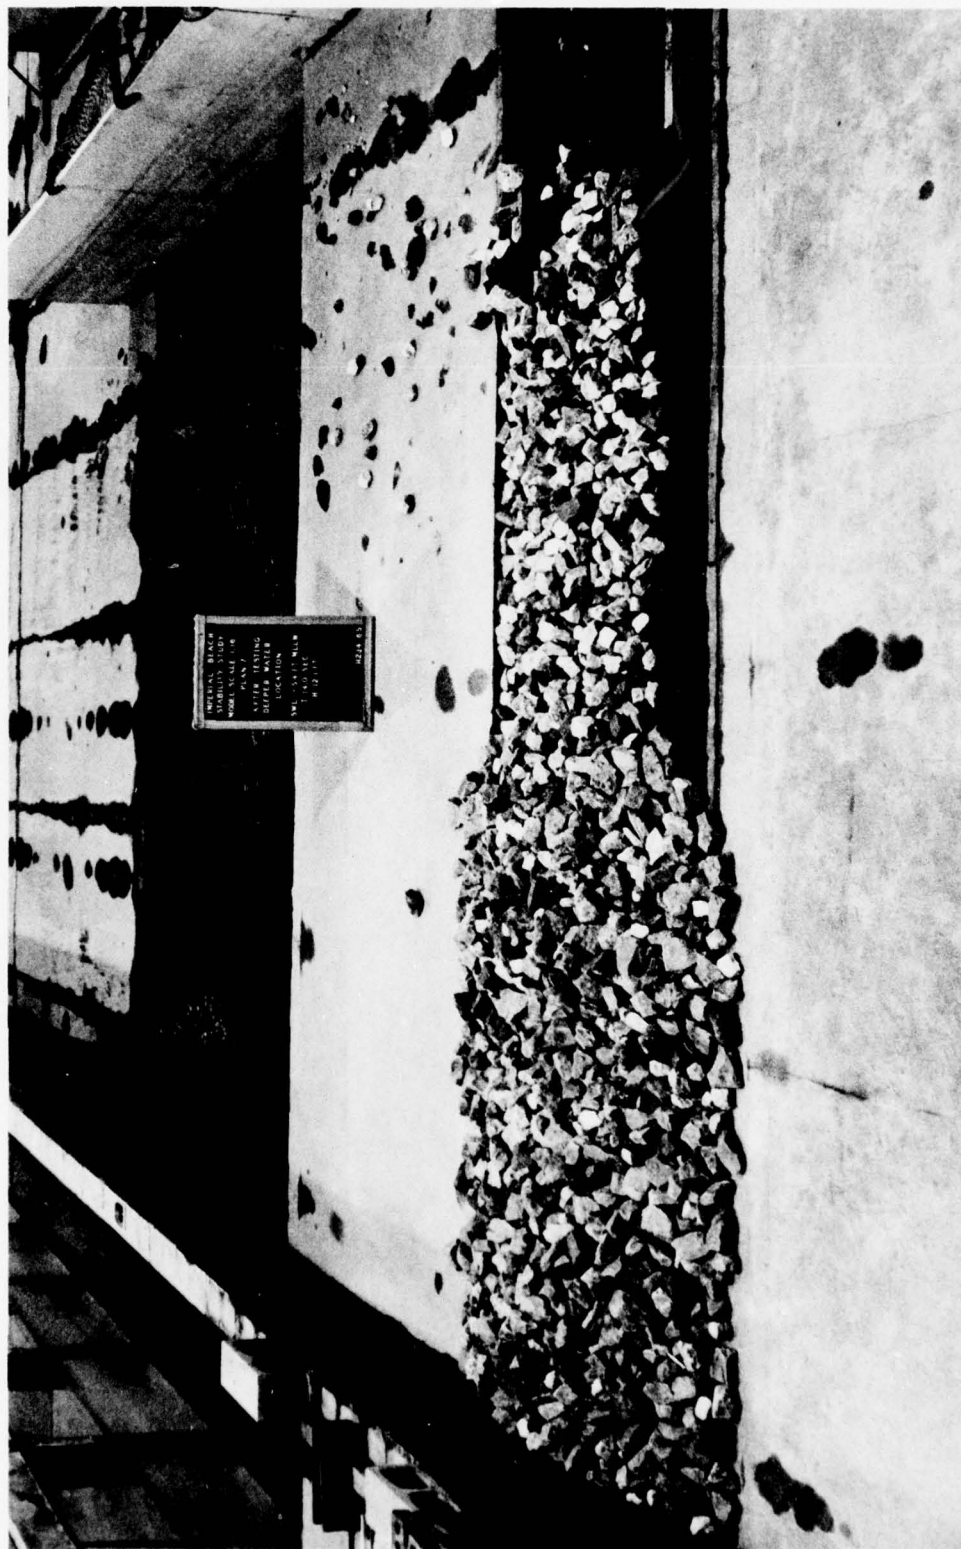
Photo 29. Sea-side view of Plan 7 in the deeper water location after 2.0 hr of 14.0-sec, 12.1-ft waves at an swl of +5.4 ft mllw

condition was changed to 14.0-sec, 12.1-ft waves at an swl of +5.4 ft mllw. After 2.0 hr of exposure to this wave condition, the high-sill and low-sill trunk had experienced very little displacement; however, the low-sill head section showed significant damage (Photo 29) and had not stabilized.

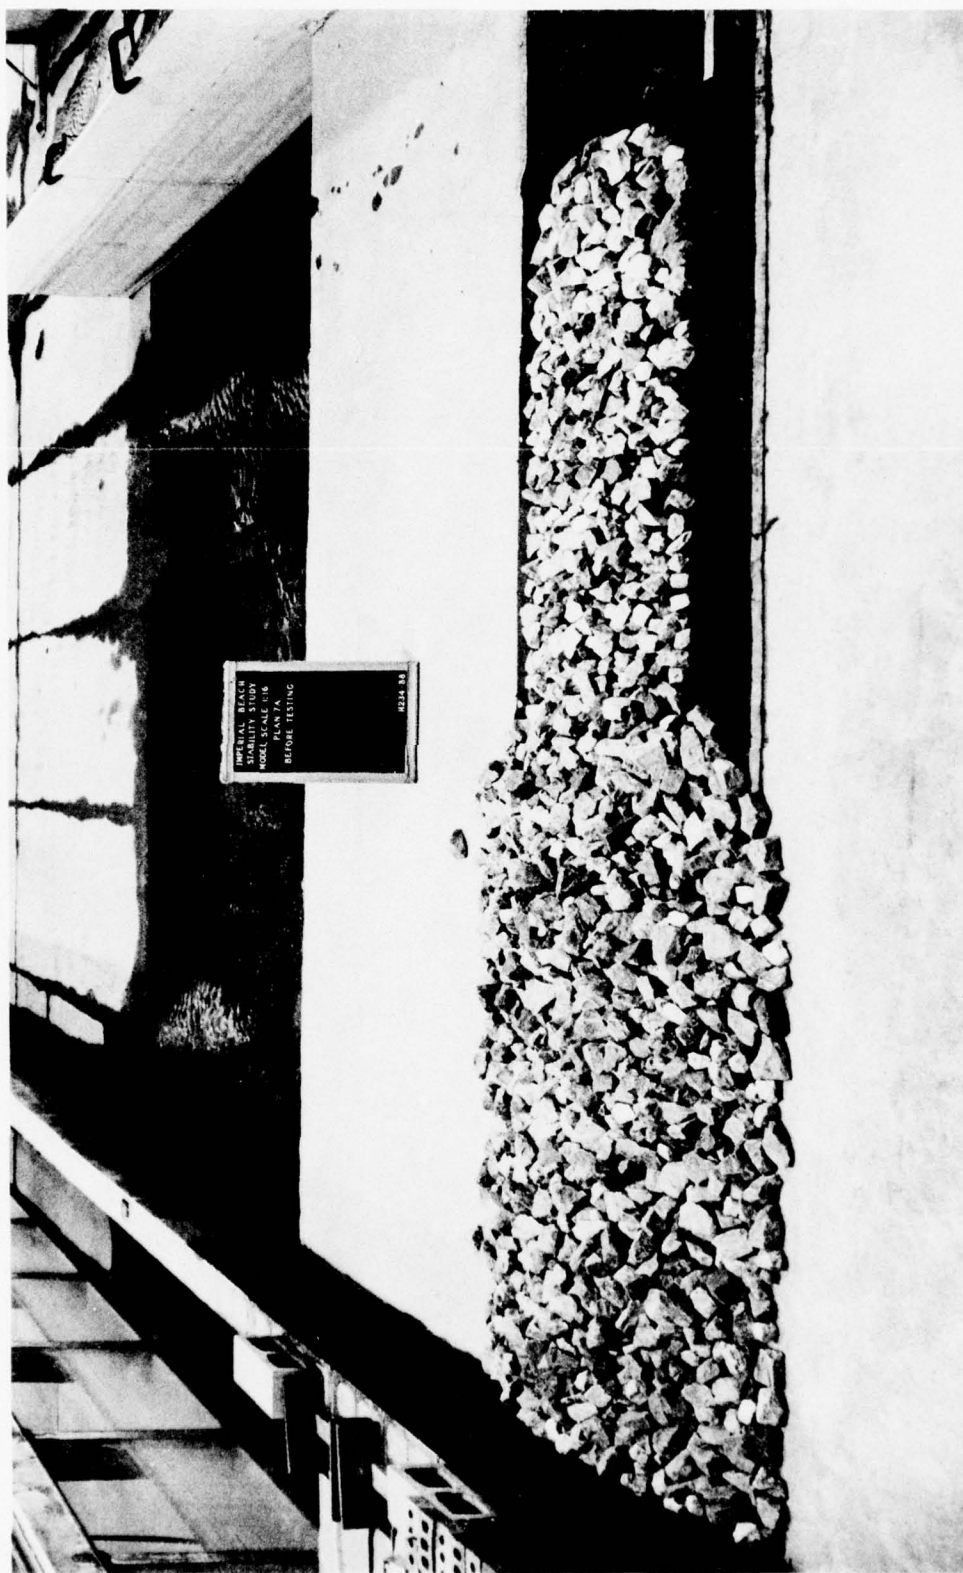
Photo 30. Sea-side view of Plan 7A before wave attack

19. Plan 7A (Plate 8 and Photo 30) was the same as Plan 7, except that the last 15 ft of the trunk and the entire head of the low sill were replaced with 5.0-ton graded armor stone identical with that used on the high sill in Plan 7. The high-sill section was not rebuilt after testing Plan 7, but the low-sill trunk was rebuilt for Plan 7A testing. After 2.0 hr of exposure to 14.0-sec, 12.1-ft waves at an swl of +5.4 ft mllw, the high-sill section and the low-sill trunk experienced very little movement while the 5.0-ton graded armor on the head of the low sill sustained significant damage (Photo 31). The identical test conditions were extended for an additional 2.0 hr to determine if the damage to the head section would stabilize. The head section continued to deteriorate and did not stabilize (Photo 32). The high-sill section and low-sill trunk (6.0 hr and 4.0 hr, cumulative testing at +5.4 ft mllw swl, respectively) remained in acceptable condition.
